Intel[®] 82801DBM I/O Controller Hub 4 Mobile (ICH4-M)

Specification Update

September 2006

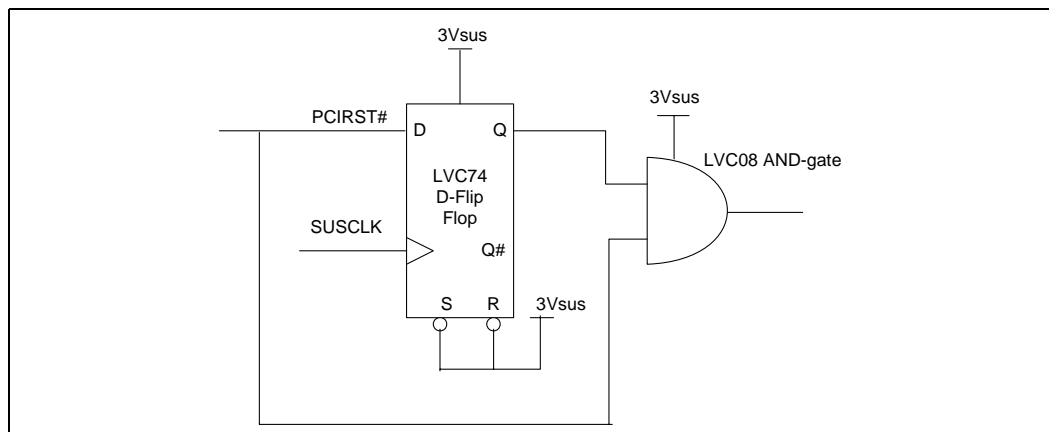
Problem: The ICH4-M specified 1–3 RTC timing of SUS_STAT# inactive to PCIRST# inactive violates the LPC Rev 1.0 specification of “at least 60 μ s.”

Implication: Some LPC devices (based on LPC Rev 1.0) may not properly reset resulting in failure of the system to boot or resume from a sleep state.

Workaround:Use any one of these three workarounds:

1. Delay PCIRST# by 1 SUSCLK using a D-flop and an AND gate to the LPC devices.
